Wetland Surface Flow and Stream Crossings

Mac McLean Alaska Department of Fish and Game

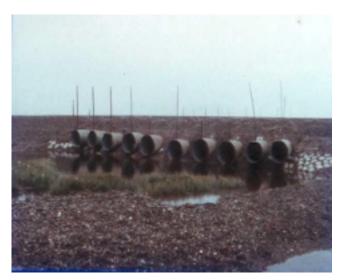
Obviously, culverts can create barriers to fish passage. A prime example in this picture is a culvert battery that was installed with either a combination of being undersized and/or a failure to provide sufficient outlet scour protection. As you can see, what has happened is a degradation of the stream back to about here, it has dropped the downstream thalweg elevation. the outlet has become perched, and outwash gravel has formed a berm right downstream of the culverts. At low water, water

percolates or french drains through these berms, and they are barriers to fish. The second thing that can happen, as you may note here in the picture, is that is often is standard practice to block the inlet and outlet to these pipes with plywood or some other structure during the winter months to try to keep snowdrifts out of them. This is done so they do not ice up, and are free to flow during breakup. Sometimes the plywood barriers are not removed prior to breakup. In those cases, the plywood becomes the barrier.
